Investigation of Smooth Specimen SCC Test Procedures. Variations in Environment, Specimen Size, Stressing Frame, and Stress State

Final Report - Part II

Reported by: B.W. Lifka
D.O. Sprowls
R. A. Kelsey
Alcoa Research Laboratories

Prepared for
George C. Marshall Space Flight Center
Contract No. NAS 8-21487

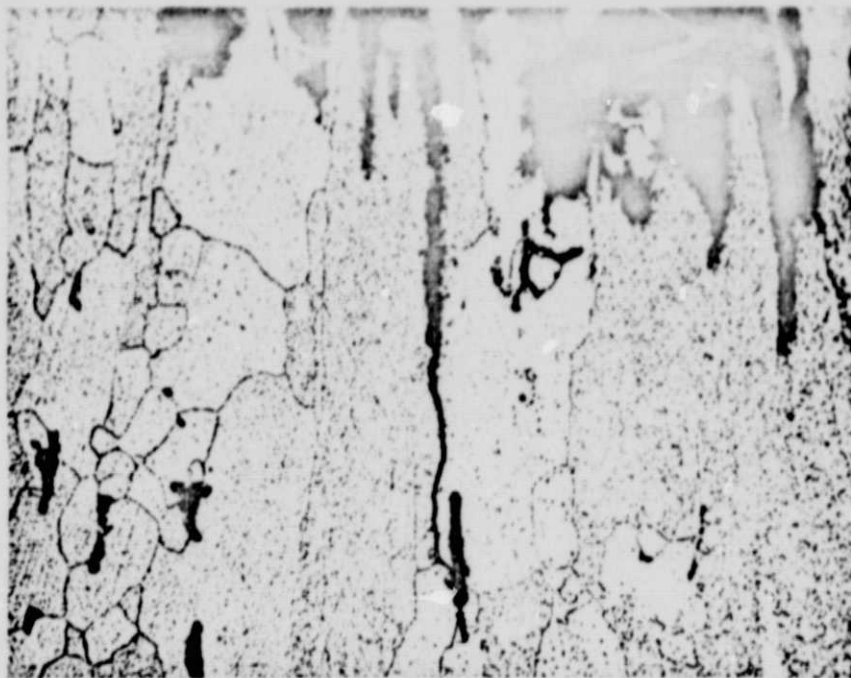
FIGURE 6 - 2024-T851 ALLOY, 1/8-IN. DIA. SPECIMEN IN FRAME A, STRESSED 90% Y.S. FAILED AFTER 5 DAYS EXPOSURE TO HIGH PURITY SALT SOLUTION. NOTE THE SHORT INTERGRANULAR CRACK EMANATING FROM THE PITTING ATTACK. NUMEROUS SUCH CRACKS WERE FOUND IN ALL FAILED 2024-T851 SPECIMENS INDICATING FAILURE BY SCC.

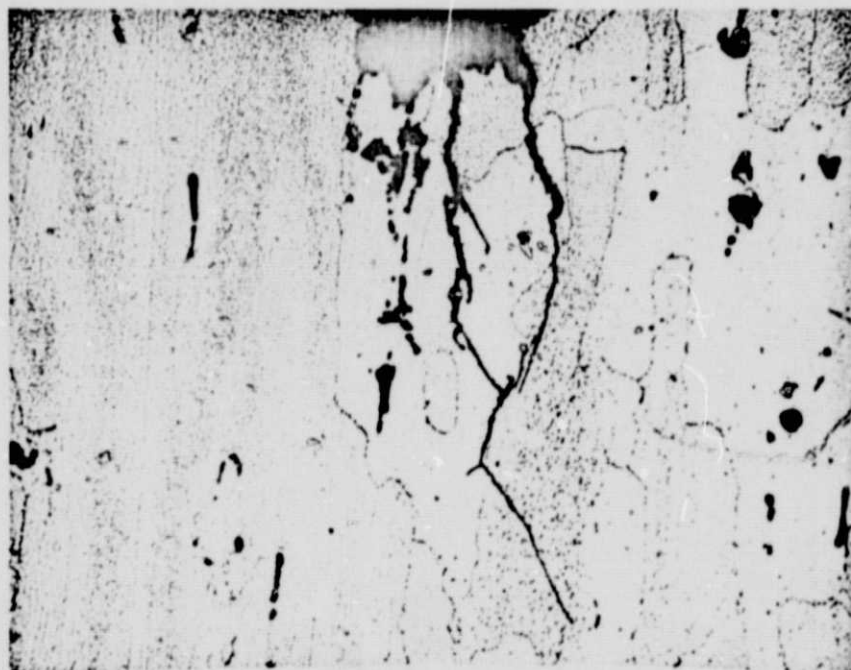
FIGURE 7 - 7075-T7351 ALLOY, 1/8-IN. DIA. SPECIMEN IN FRAME A, STRESSED 90% Y.S., FAILED AFTER 45 DAYS EXPOSURE TO HIGH PURITY SALT SOLUTION. NUMEROUS TRANSGRANULAR CRACKS, SUCH AS THE ONE ILLUSTRATED, WERE FOUND IN ALL 7075-T7351 SPECIMENS EXAMINED WITH NO EVIDENCE WHATSOEVER OF INTERGRANULAR CRACKING. THIS INDICATES THE 7075-T7351 FAILURES WERE NOT TYPICAL INTERGRANULAR STRESS-CORROSION CRACKING

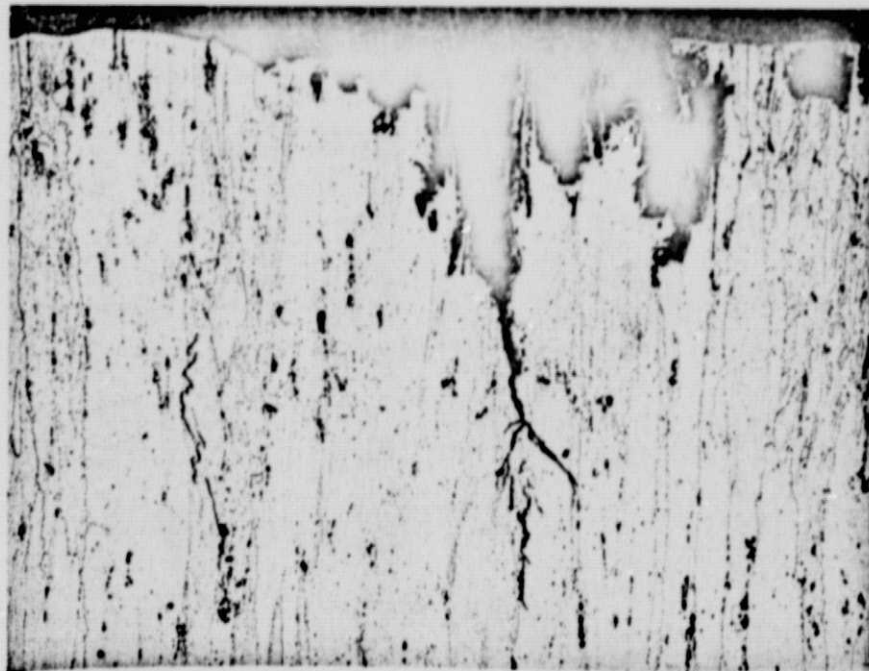
FIGURE 8 - 7XXX-T7351 ALLOY, 1/8-IN. DIA. SPECIMEN IN FRAME A, STRESSED 90% Y.S. FAILED AFTER 17 DAYS EXPOSURE TO HIGH PURITY SALT SOLUTION. NUMEROUS TRANSGRANULAR CRACKS, AND NO INTERGRANULAR CRACKING WERE DETECTED IN ALL 7XXX-T7351 SPECIMENS EXAMINED.

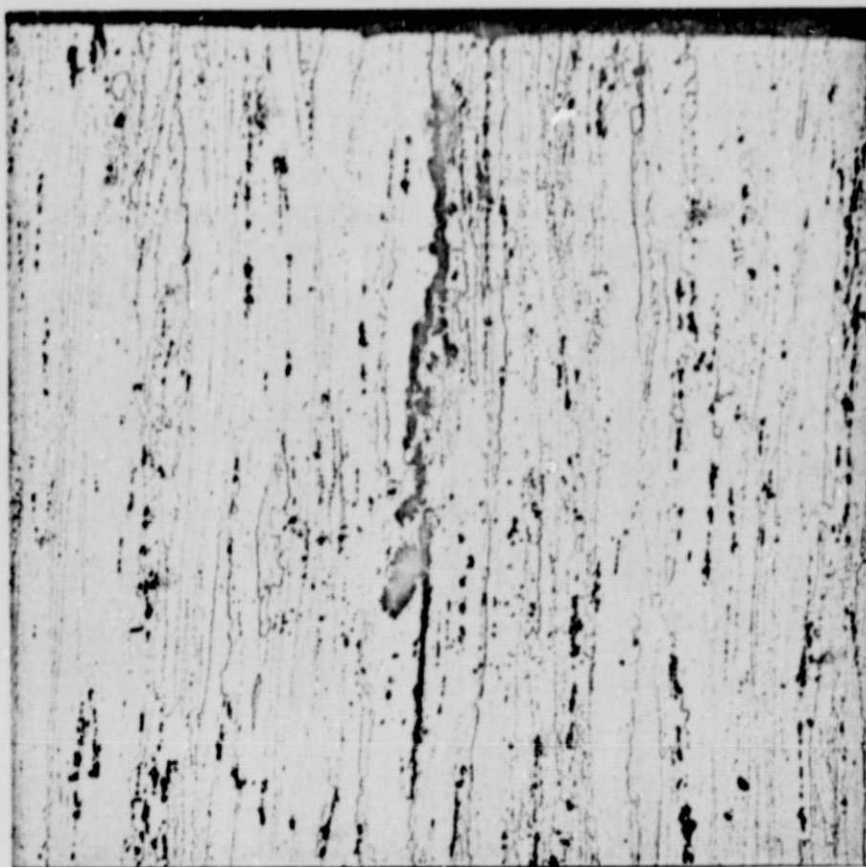
FIGURE 12 - AN AUXILIARY CRACK PARALLEL TO THE MAIN FRACTURE IN A 7XXX-T7351 SPECIMEN THAT FAILED AFTER 4 DAYS EXPOSURE TO BOILING 6% NaCl SOLUTION AT A STRESS OF 46 KSI. THE CRACK IS REPRESENTATIVE OF THE AUXILIARY CRACKS IN THIS AND OTHER 7XXX-T7351 SPECIMENS THAT FAILED IN THIS ENVIRONMENT AND IS CONSIDERED TO BE THE RESULT OF STRESS-CORROSION CRACKING. NOTE THE ABSENCE OF ANY APPRECIABLE PITTING CORROSION OF SURFACE IN THIS ENVIRONMENT COMPARED WITH THAT WHICH OCCURRED IN THE 3.5% NaCl ALTERNATE IMMERSION TEST , SEE FIGURES 8 AND 9.

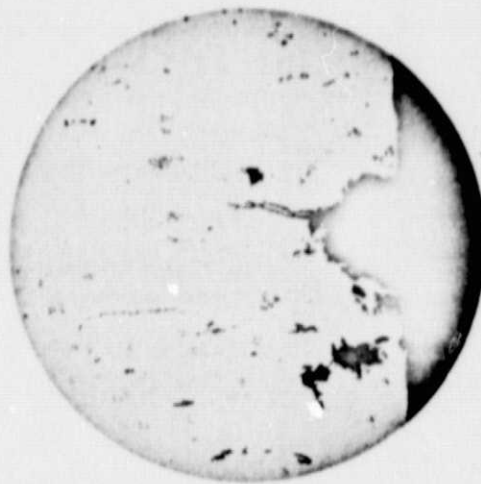
FIGURE 14 - SECTION (20X) THROUGH THE GAGE LENGTH OF AN 1/8-IN. 7075-T7351 SPECIMEN CORRODED UNDER STRESS, REMOVED PRIOR TO FAILURE AND THE THEN TENSILE TESTED. NUMEROUS SHORT, TRANSGRANULAR CRACKS EMANATED FROM SITES OF PITTING CORROSION (AS ILLUSTRATED BY THE THREE 100X INSERTS) THAT DRASTICALLY REDUCED THE FINAL BREAKING STRENGTH. THIS SAME SITUATION EXISTED IN THE 7XXX-T7351 AND 2024-T851 SPECIMENS, EXCEPT CRACKING IN LATTER ALLOY WAS INTERGRANULAR.

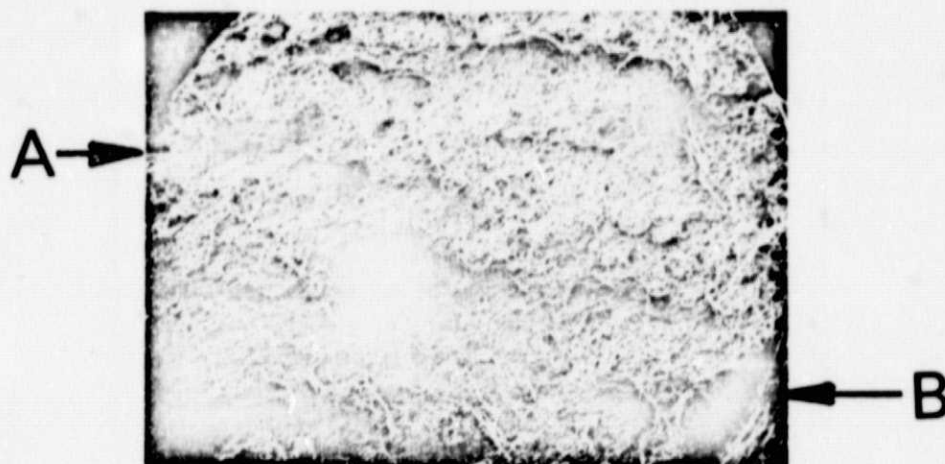
FIGURE 23 - SEM FRACTOGRAPHS OF A 0.250 IN. SPECIMEN OF 7XXX-T7351 ALLOY STRESSED 75% YS THAT FAILED DURING 25 DAYS EXPOSURE TO THE 3.5% NaCl ALTERNATE IMMERSION. SITES A AND B INDICATE CORROSION PITS WITH TRANSGRANULAR CRACKS EXTENDING INTO THE METAL FROM THE BOTTOMS OF THE PITS

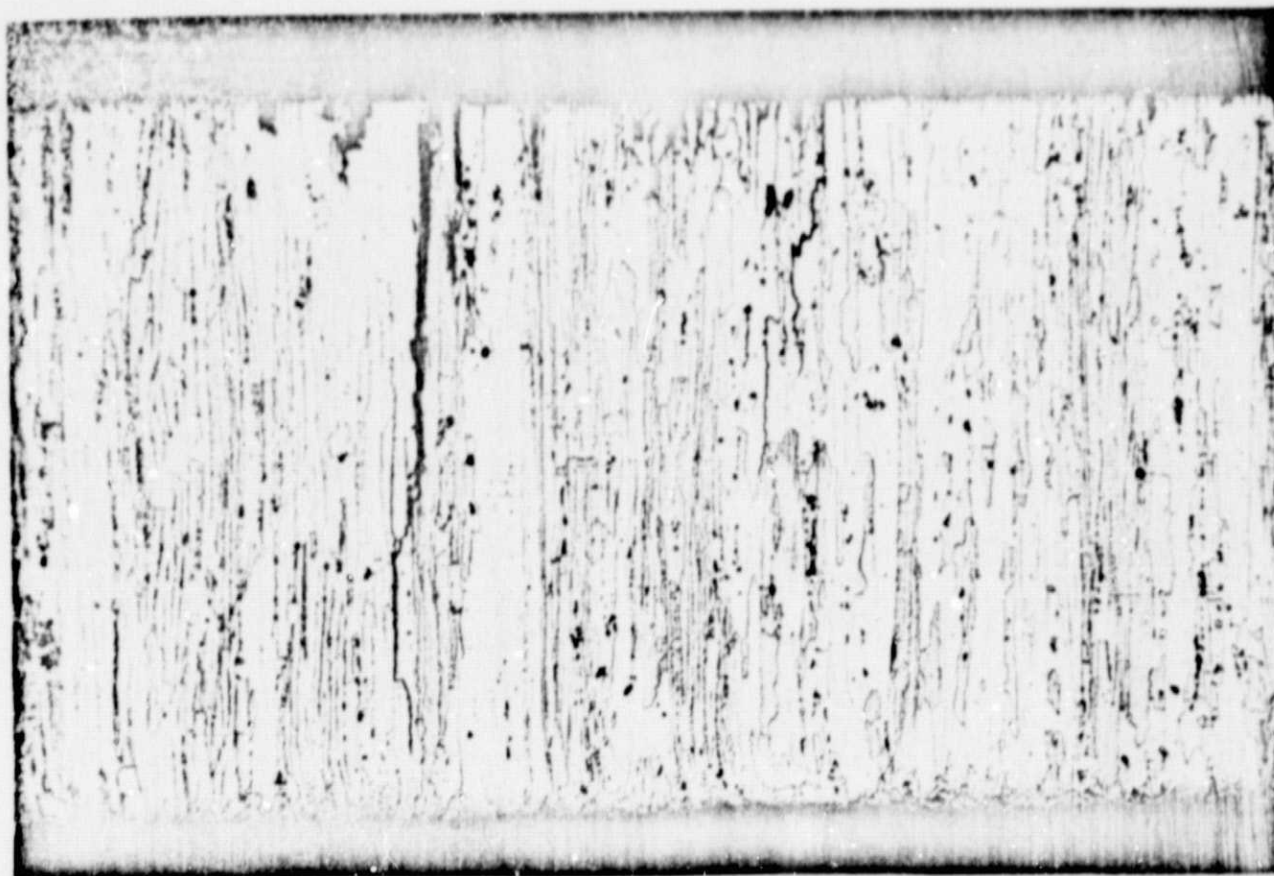
FIGURE 30 - 7075-T651 HOLLOW CORE SPECIMEN (S-367115-A3) ORIENTED IN THE SHORT TRANSVERSE DIRECTION THAT FAILED DURING THE THIRD DAY WHEN TORSION LOADED TO A STRESS OF 25 KSI.

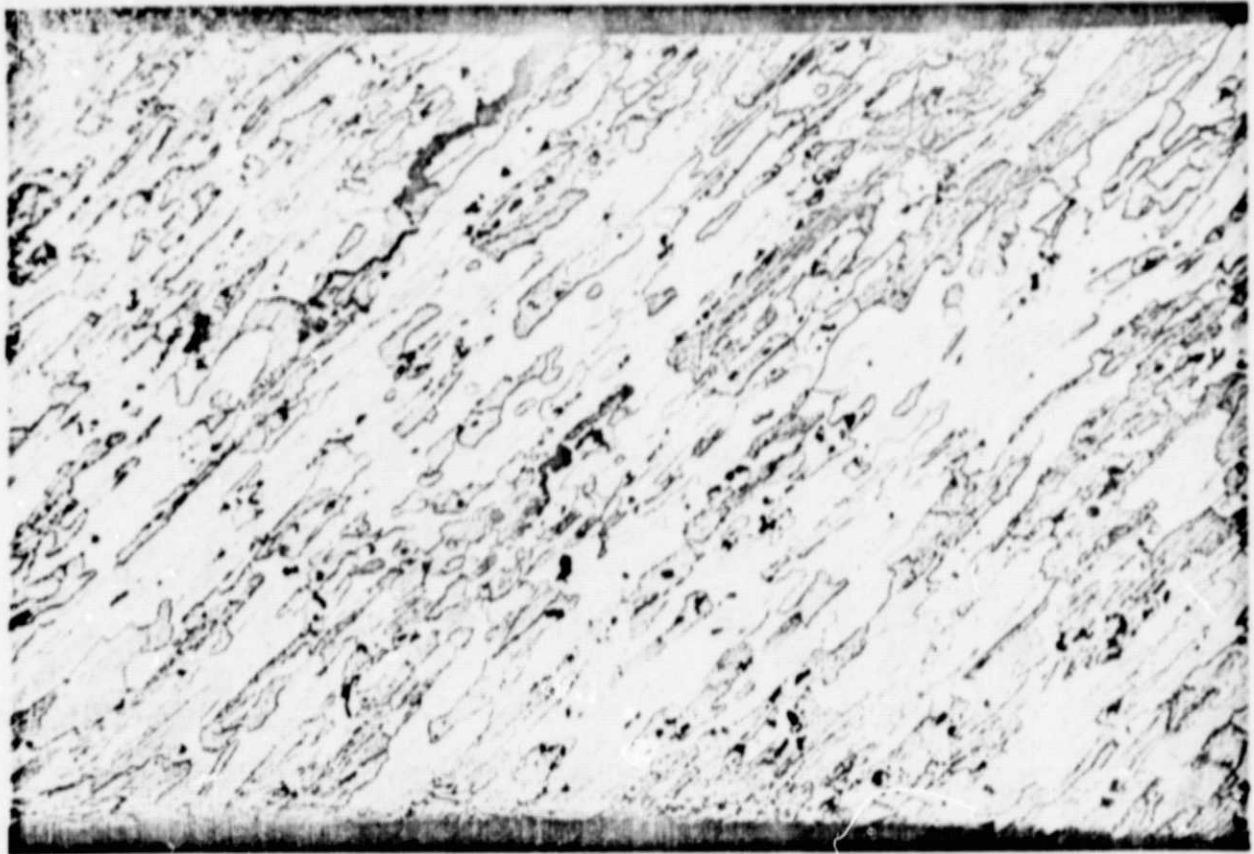
FIGURE 31 - 7075-T651 HOLOW CORE SPECIMEN (S-367115-D3) ORIENTED AT 45° TO THE LONG TRANSVERSE DIRECTION THAT FAILED IN LESS THAN 1 DAY WHEN LOADED IN TENSION TO A STRESS OF 50 KSI.
